FINAL
ASBESTOS SURVEY REPORT
FOR
NATIONAL AIR AND SPACE MUSEUM
VOLUME I

Smithsonian Institution
Office of Design and Construction
955 L'Enfant Plaza, Suite 3230
Washington, D.C. 20060

Versar, Inc.
6850 Versar Center
Springfield, Virginia 22151

November 25, 1992

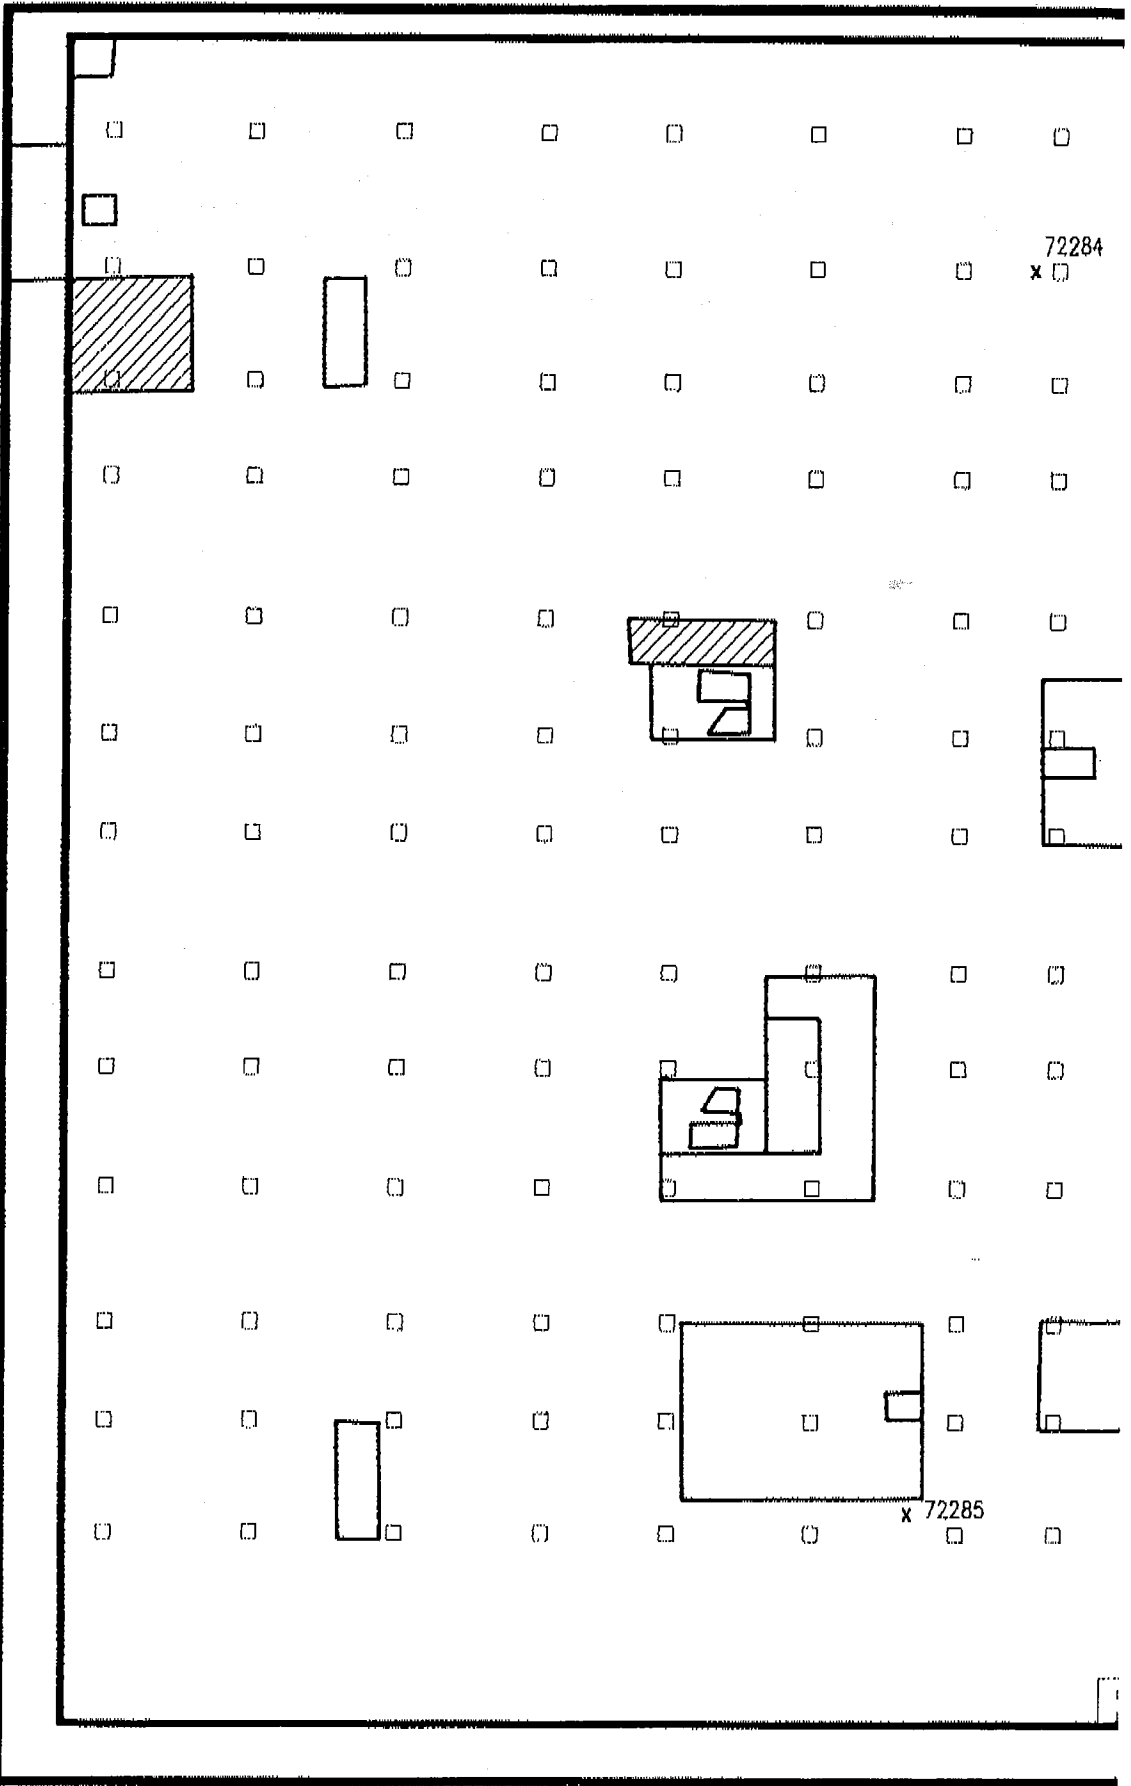
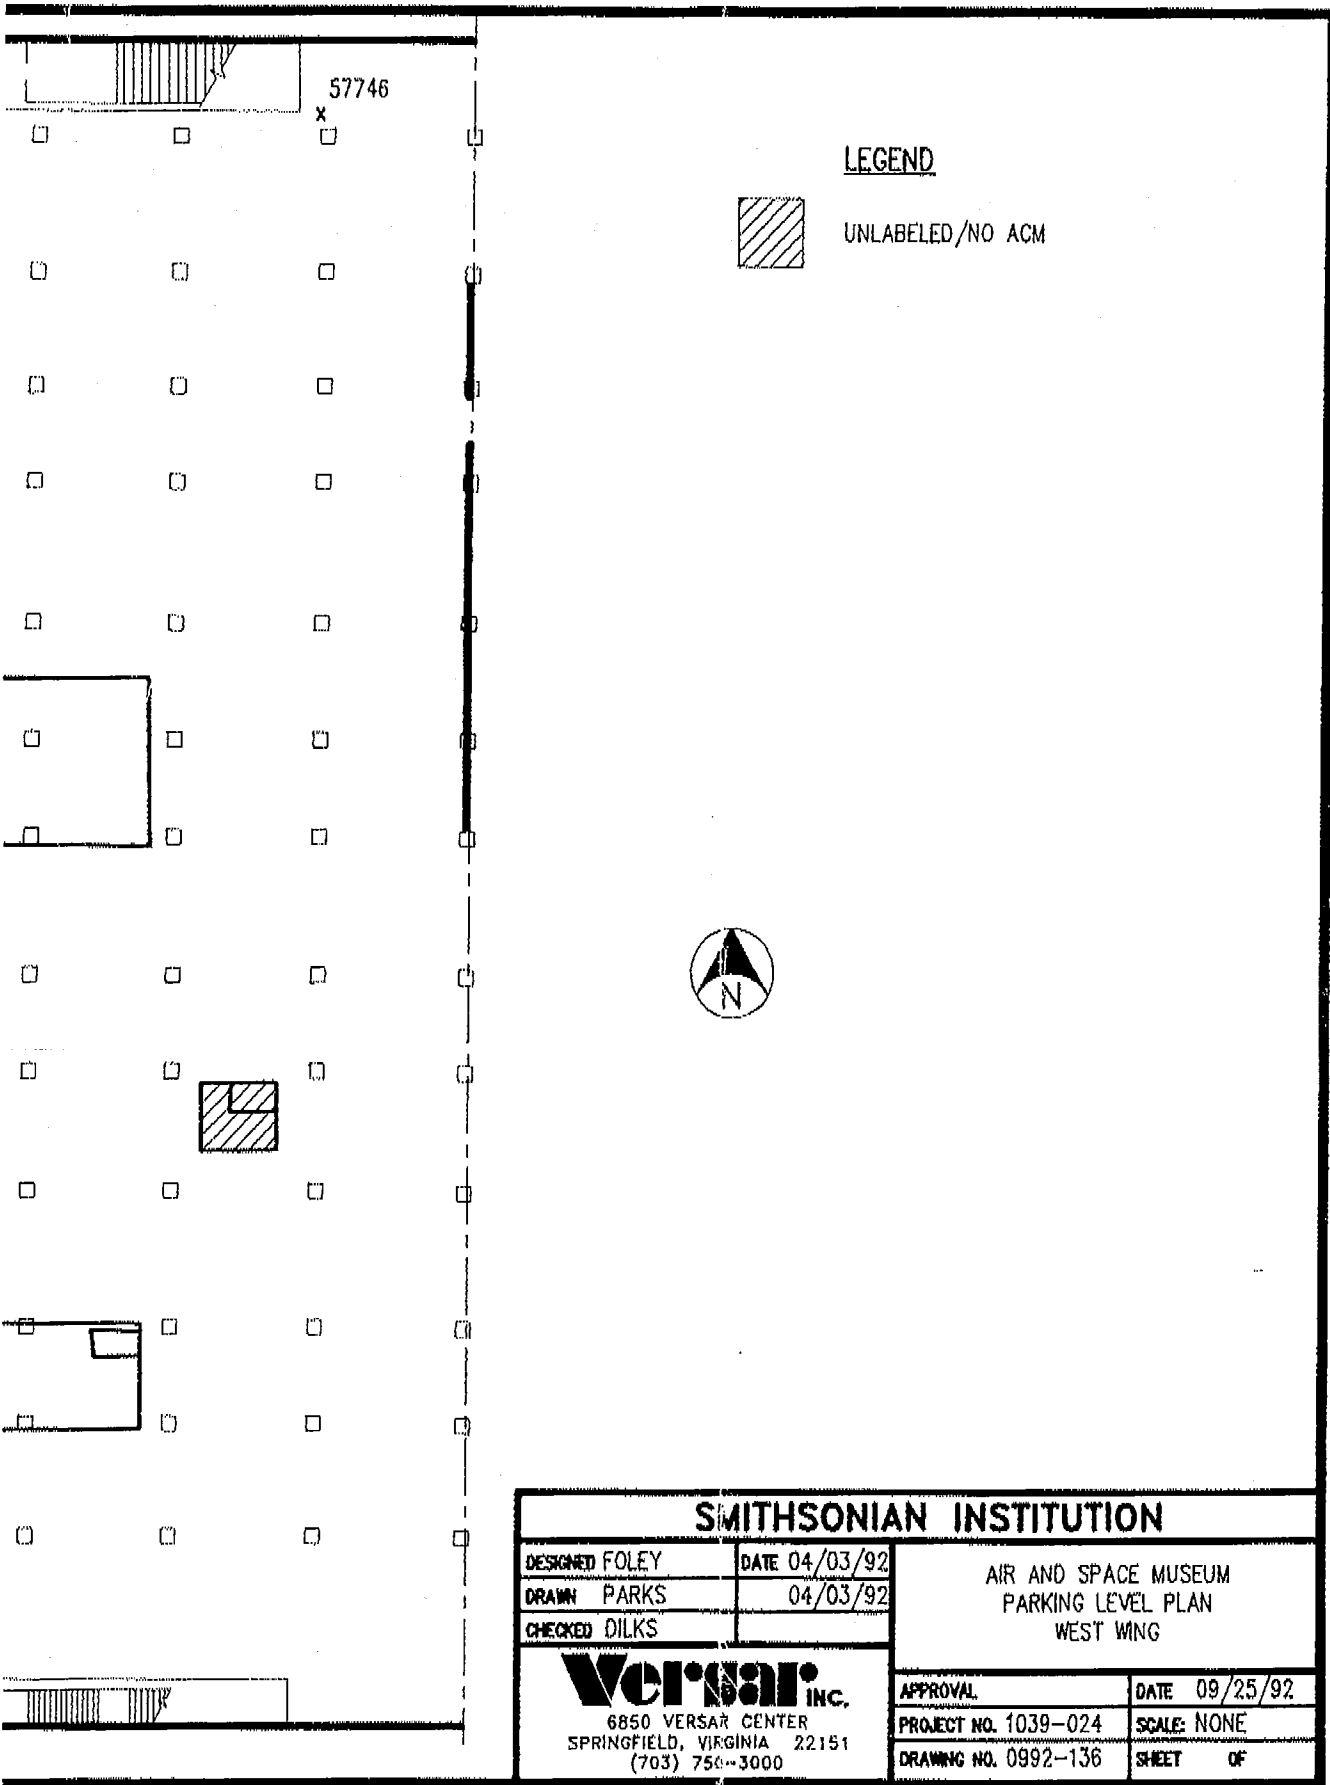
APPROVAL	DATE 09/25/92
PROJECT NO. 1039-024	SCALE: NONE
DRAWING NO. 0992-136	SHEET OF

DRAWING: \SMT\1009\0992-13E.DWG PLOT DATE: 09-25-92

57746

A list of all samples collected in the NASM is shown in Table 1. The table includes the sample number, sample location, material description, and asbestos content of the sample. Each sample location is shown on the building floor plans (Figure 2). The Smithsonian Institution requires that one sample out of 20 be sent to an outside laboratory for Quality Control (QC) analysis. The QC samples are denoted in Table 1 with an asterisk (*), and the outside laboratory results are found in Appendix A. Sample results from the outside laboratory correspond to Versar's laboratory results in relation to each sample collected during the NASM survey.

Approach: After review of the entire report, the reader should first identify which rooms are located in the wing to be renovated. This is easily accomplished by checking the floor plan (Figure 2) in Section 5.0. The room numbers listed on the floor plan correspond to those in the spreadsheet. Note that these numbers were obtained from ODC floor plans and do not reflect later number changes that may have been made by the facility. Actual room numbers may need to be verified before proceeding. Working with the floor plan and spreadsheet, each room in the wing can then be checked for asbestos-containing materials. The spreadsheet provides the quantities, sample information, response code, and removal and replacement costs. Once the various types of ACM are identified on the spreadsheet, the reader should proceed to the appropriate subsection of Section 6.0 (Conclusions and Recommendations) for more detailed information regarding the material condition, sample information, and recommended control

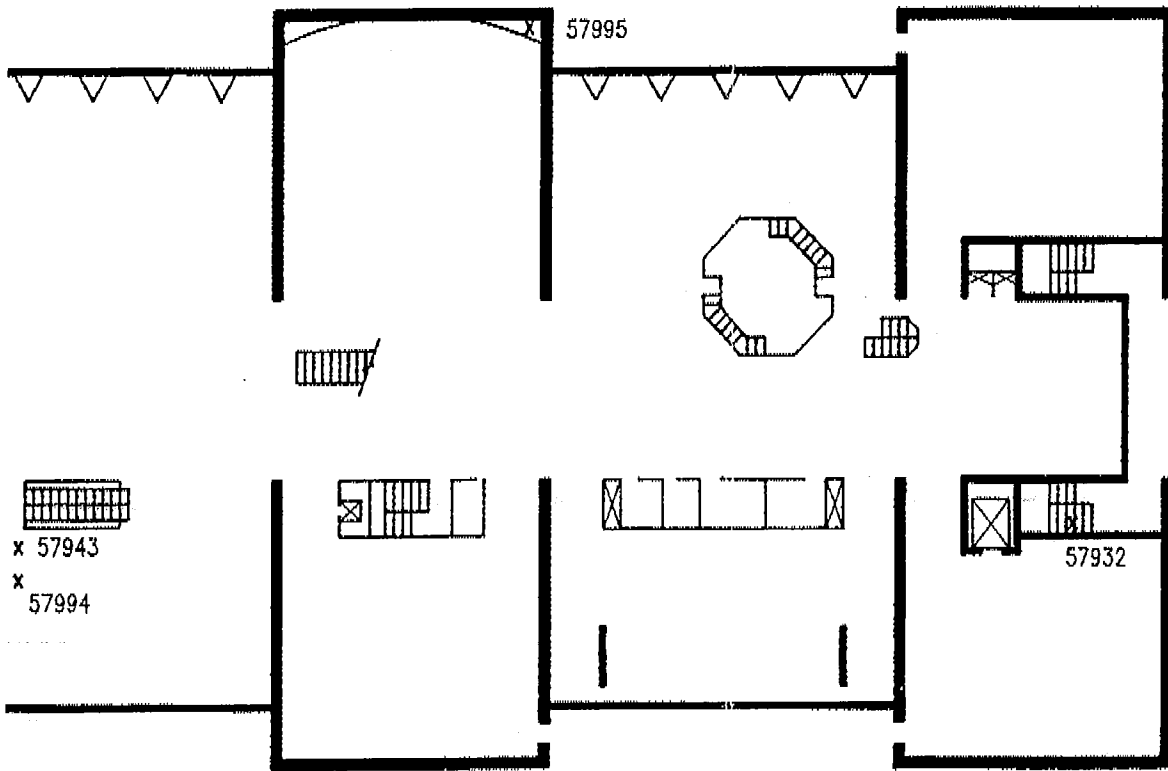
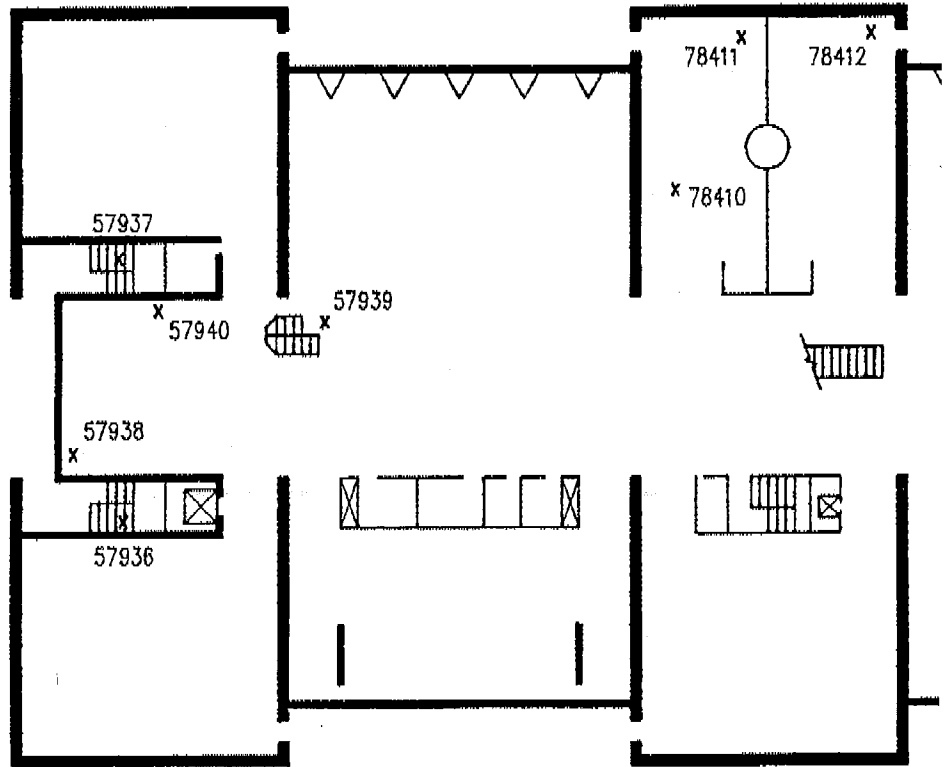
SMITHSONIAN INSTITUTION			
DESIGNED FOLEY	DATE 04/03/92	AIR AND SPACE MUSEUM FIRST FLOOR PLAN	
DRAWN PARKS	04/03/92		
CHECKED DILKS			
Versar INC. 6850 VERSAR CENTER SPRINGFIELD, VIRGINIA 22151 (703) 750-3000		APPROVAL	DATE 05/26/92
		PROJECT NO. 5265.024	SCALE NONE
		DRAWING NO. ASM-1	SHEET OF

x 57943
x 57994

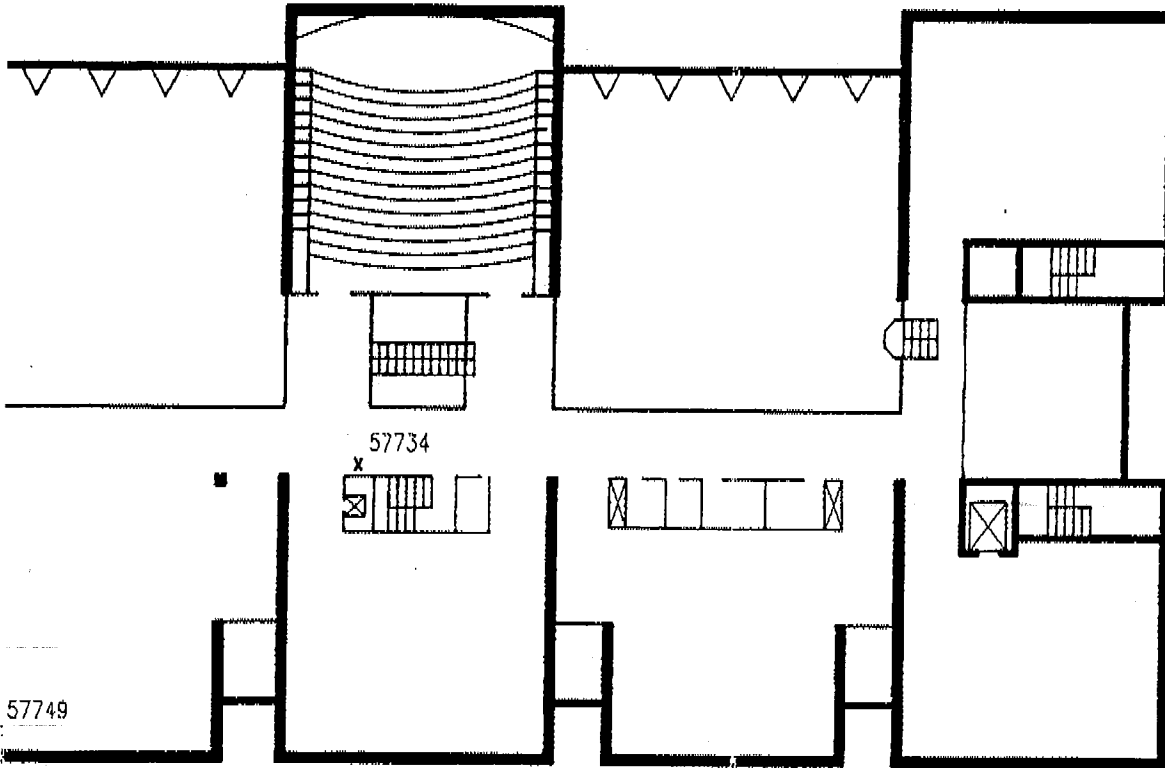
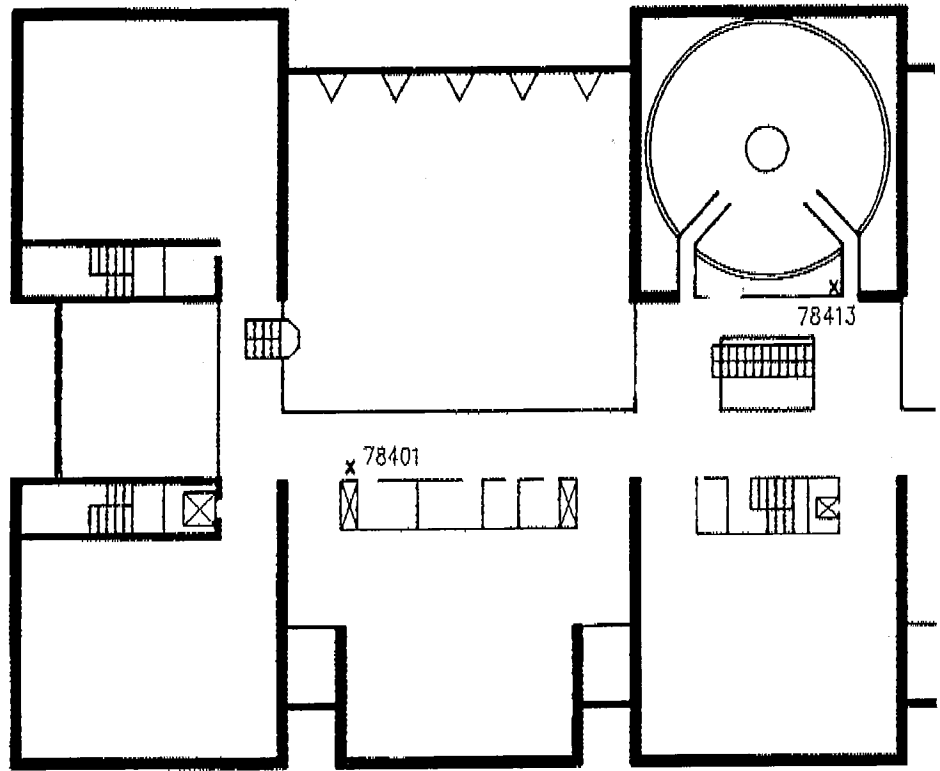
SMITHSONIAN INSTITUTION			
DESIGNED FOLEY	DATE 04/03/92	AIR AND SPACE MUSEUM SECOND FLOOR PLAN	
DRAWN PARKS	04/03/92		
CHECKED DILKS			
Versar INC. 6850 VERSAR CENTER SPRINGFIELD, VIRGINIA 22151 (703) 750-3000		APPROVAL	DATE 05/26/92
		PROJECT NO. 5265.024	SCALE: NONE
		DRAWING NO. ASM-2	SHEET OF

PROJECTION ROOM

MEZZANINE LEVEL
